S35 Monitoring Report Quail Rise Special Zone

Planning Policy Queenstown Lakes District Council March 2025

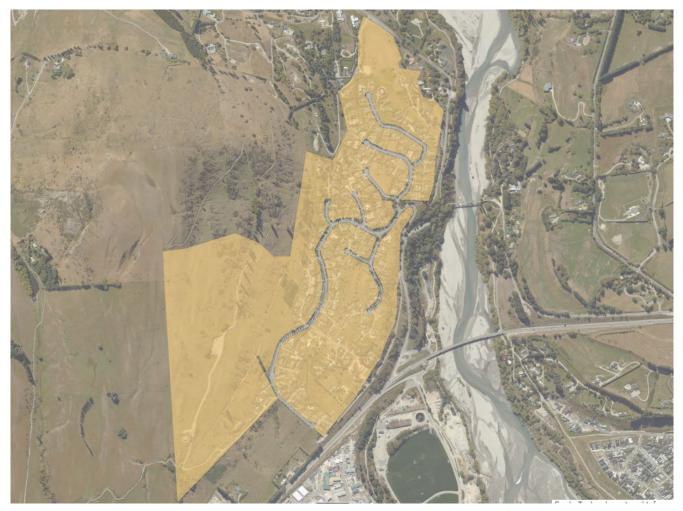
Figure 1. Extent of the Quail Rise Special Zone (yellow) in the Operative District Plan

The Quail Rise Special Zone provides for low density residential living in a sustainable manner that conserves and enhances amenity and rural character. The area has already been developed under the former Shotover Resort Zone provisions. However, the resort character of the zone did not eventuate, and Quail Rise developed as a low-density residential area adjoining both rural and rural-residential settings. The extent of the Zone is shown in Figure 1 below.

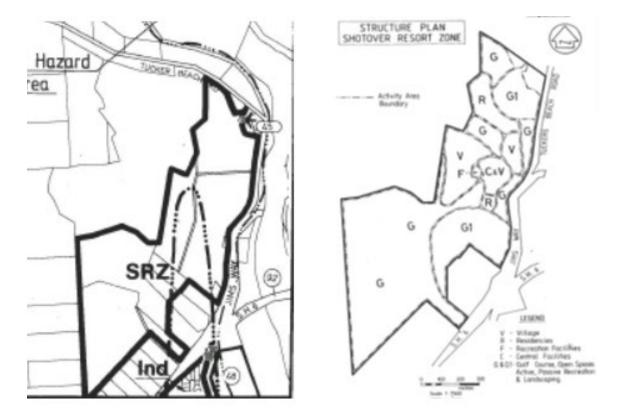
Figure 2. Extent of the Shotover Resort Zone (left) and the Structure Plan (right) from the 1995 Proposed District Plan

The Hearings Committee recognised the potential of the Shotover Resort to contribute to the high demand for rural residential living for permanent residents and visitors alike in a manner that conserves and enhances an attractive amenity and rural setting. The extent of the Shotover Resort Zone from the 1995 Proposed District Plan is shown in Figure 2 below. ¹

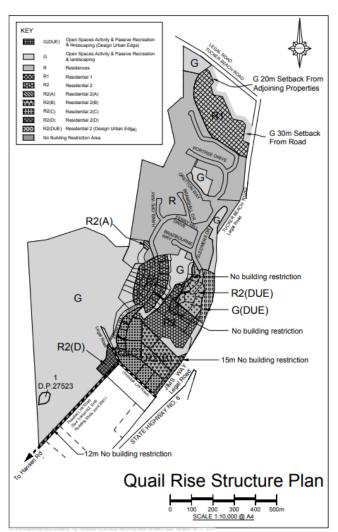
Figure 3. Current Quail Rise Structure Plan

The hearing for Plan Change 37 commenced on the 29th of September 2010 and the decision was ratified as a Council decision by council on the 17th of December 2010. The decision resulted in an additional 23 residential dwellings, four new Activity Areas and enabled the development of 214 residential units within the QRSZ. Ity was made fully operative on the 13th of October 2011, and the structure plan in Figure 3 approved through PC 37 is the operative Structure Plan.²

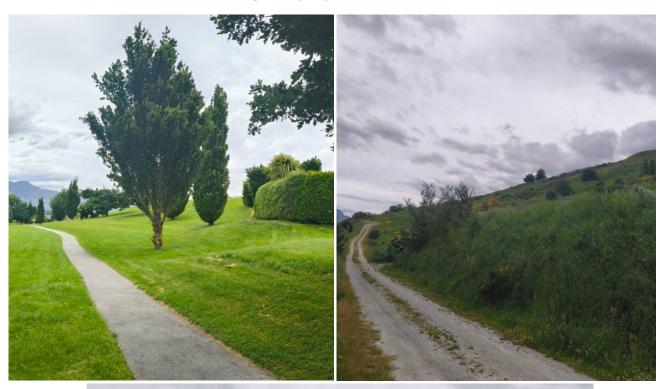
Figure 8. Open Space Areas with QRSZ

1.2 To ensure that open space is maintained and enhanced through appropriate landscaping and the absence of buildings and other structures.	In general, the open space areas were well maintained with appropriate landscaping with the exception of the Open Space area adjacent to R2(D) & Ferry Hill Drive, see image two from Figure 8. This open space area is on the edge of residential development rather than being located within in, so this did not have much impact on the amenity of the zone despite the lack of landscaping and maintenance.

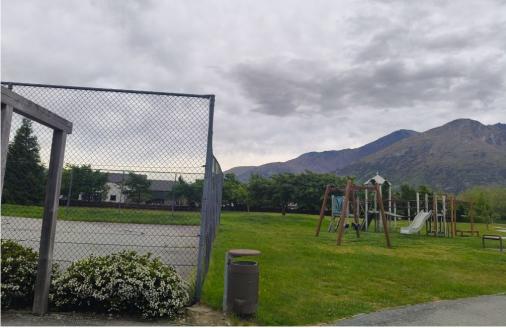
Figure 9. Open Space Areas Zoned Open Space Recreation/Designations under PDP (brown)

1.3 To ensure that open space is developed in a comprehensive manner.	There has been one Non-Complying and one Restricted Discretionary Breach for a residential building within OSG under the resource consent RM120709. ⁶ To mitigate the visual effects of this dwelling within the OSG, a 1.25m bund and planting was required.
	There were some structures located within one of the open spaces, including a tennis court and playground which is now zoned as Informal Recreation Zone in the PDP (see image three from Figure 8). However, it can be argued that these structures contribute to the general amenity of these open spaces rather than from detracting from them.
	It appears that in general the open space has been developed in a comprehensive manner, except for Open Space G adjacent to R2(D) and the OSG next to R1, as they have been all rezoned Informal Recreation under the PDP and are being managed by the QLDC Parks and Reserves Team in a comprehensive manner following this rezoning. See Figure 9.
