The D L Kenton Family Trust  
 Geotechnical Assessment  
 1147B Lake Hawea-Albert Town Road  
 Site Plan

# Geotechnical Report for Resource Consent

This report presents the results of geotechnical investigations carried out by GeoSolve Ltd in order to determine subsoil conditions, assess natural hazards and provide geotechnical inputs and recommendations for a proposed barn and accessway at 1147B Lake Hawea-Albert Town Road, Hawea.

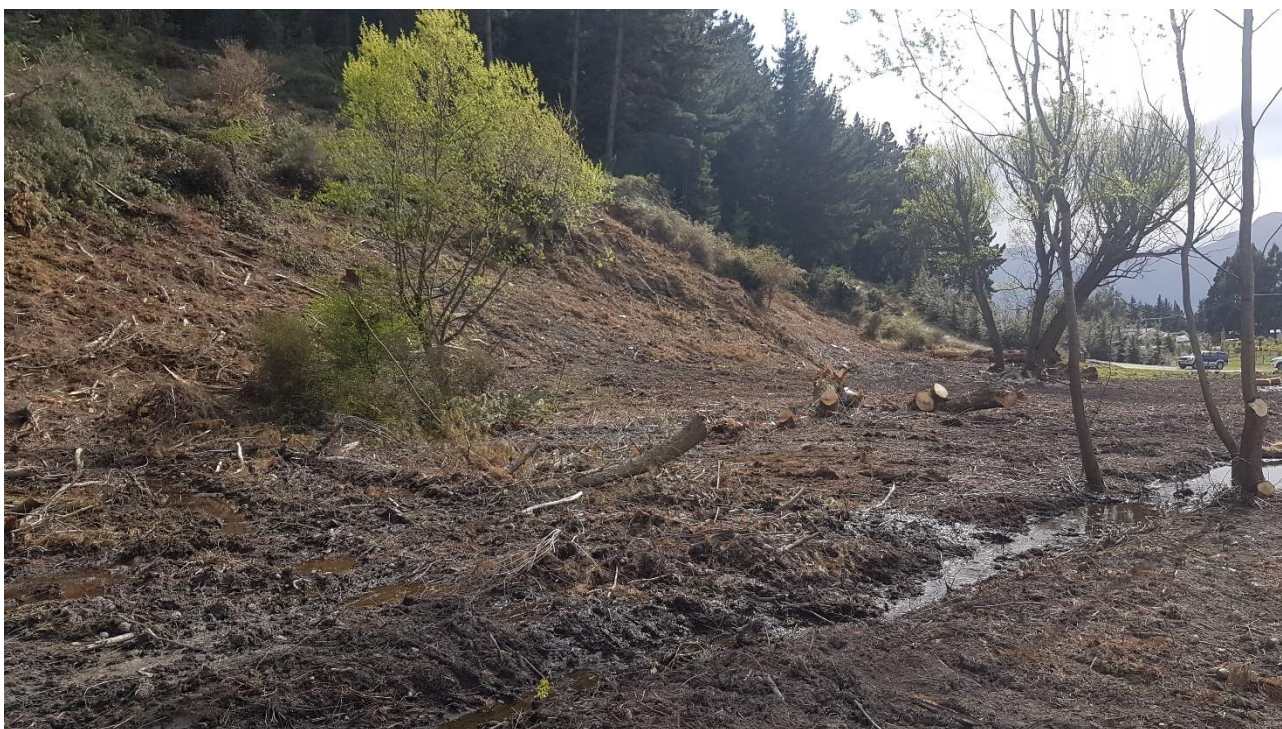
Plate 4: Detailed view of cleared area, standing water and a drainage channel are viable.

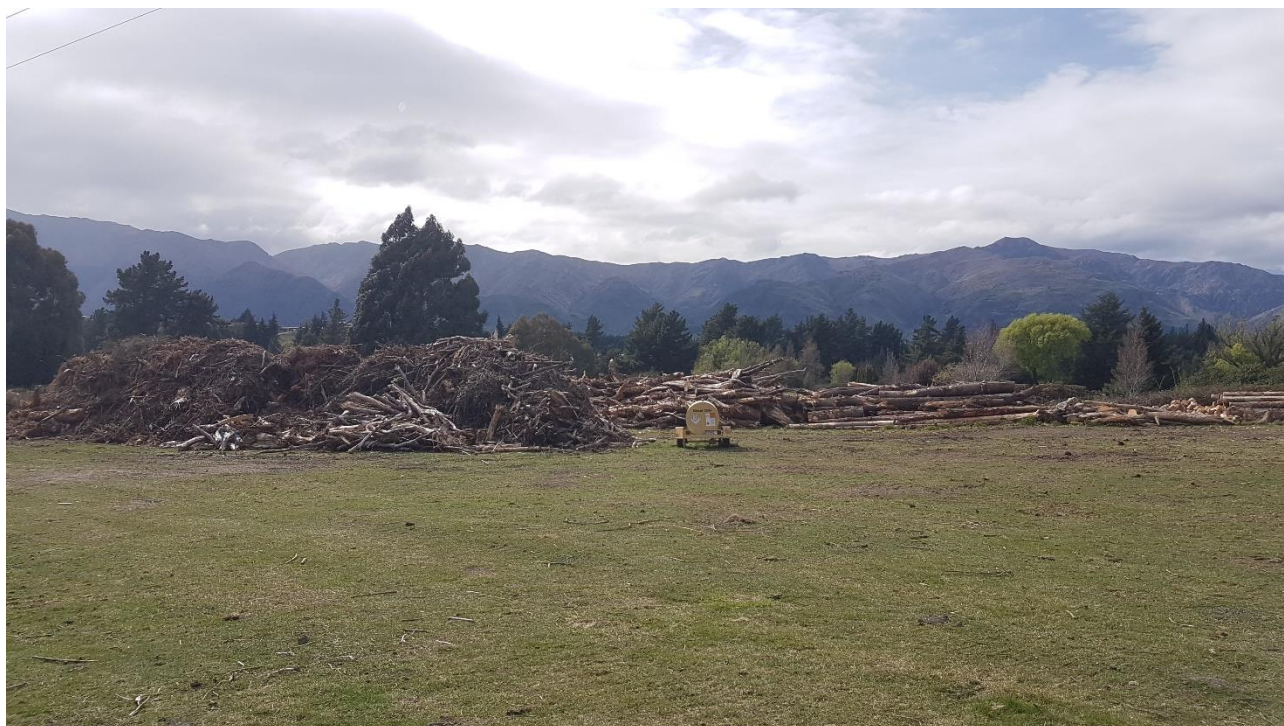
Plate 5: Debris piles waiting to be turned into mulch, small yellow diesel tank visible in front of these, no evidence of leaks was noted.

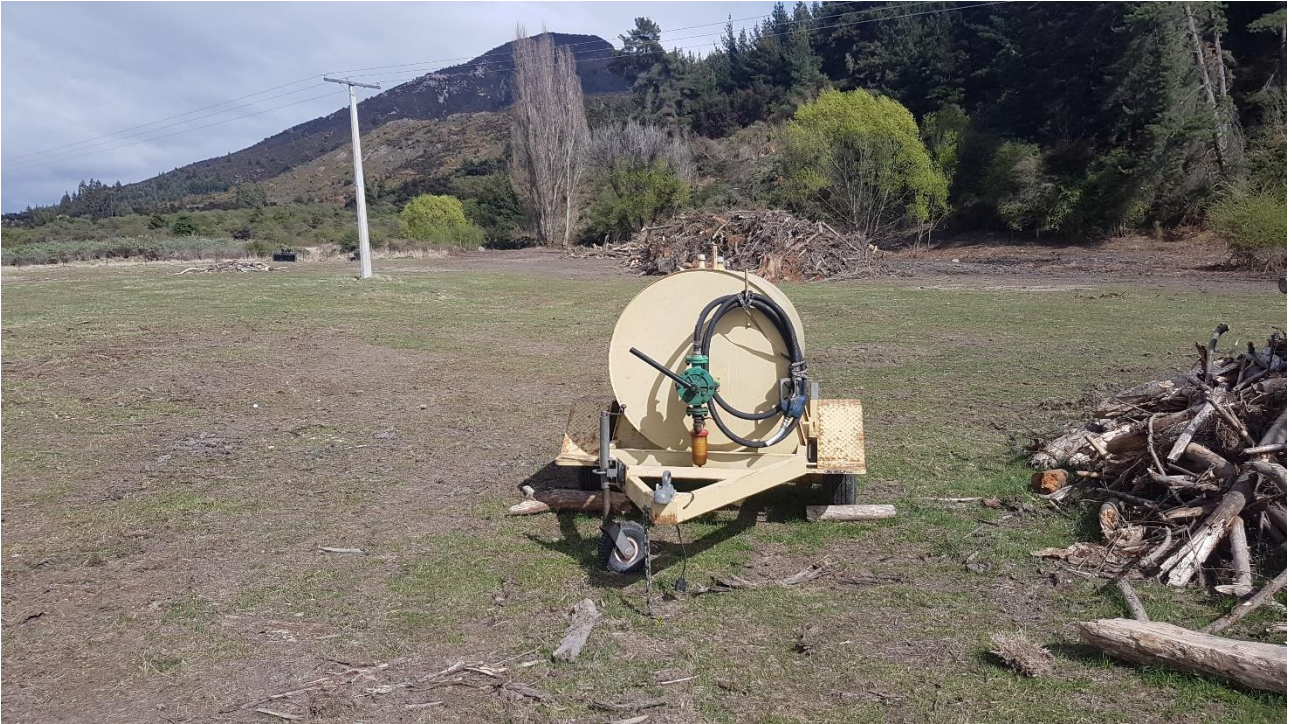
Plate 7: Portable diesel tank, appeared to be clean and in good repair.
