# Inland Water Hazard and Risk Assessment Albert Town Bridge June 2024

Carmine, J. & Stanley, T. (2024). *Albert Town Bridge Inland Water Hazard and Risk Assessment*. Report prepared for Queenstown Lakes District Council.

## Executive Summary

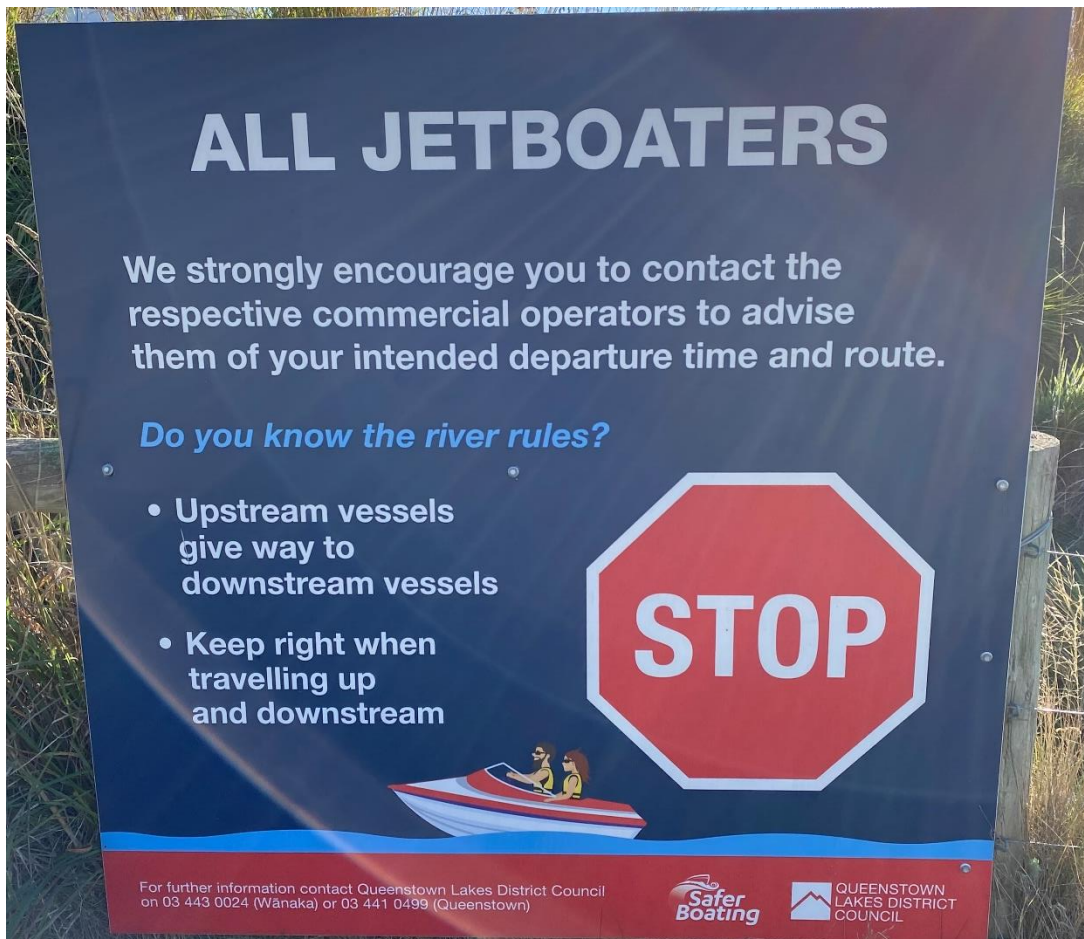
Figure 2 Jet Boat Signage

| <p>Signage:</p> <p>On the northern side of the site lies numerous signs that provide the site users with a quantity of information relating to no camping beyond this point, no soap or detergent in the river, no bathing or dishes in the river, jet boating information, Albert Town Recreation Reserve information, no powered vessel timeframe information, Clutha River fishing information.</p> <p>All signage can be seen as Figures 2 – 6.</p> <p>It was noted that there were no signs pertaining to aquatic safety for swimmers who use the site.</p> | | |

Currently, there is no aquatic safety signage located at Albert Town Bridge. Signage is recommended and all new signage should comply with the New Zealand Standard *AS/NZS 2416.1:2010*. The existing signage on site relates to river use and jet boating, but it is extensive to the point of reducing its effectiveness in conveying the intended information as noted in a study

by Portella (2016). Therefore, it is recommended that a restructuring, redesign, and consolidation of the existing signs be undertaken to improve effectiveness and meet compliance requirements.

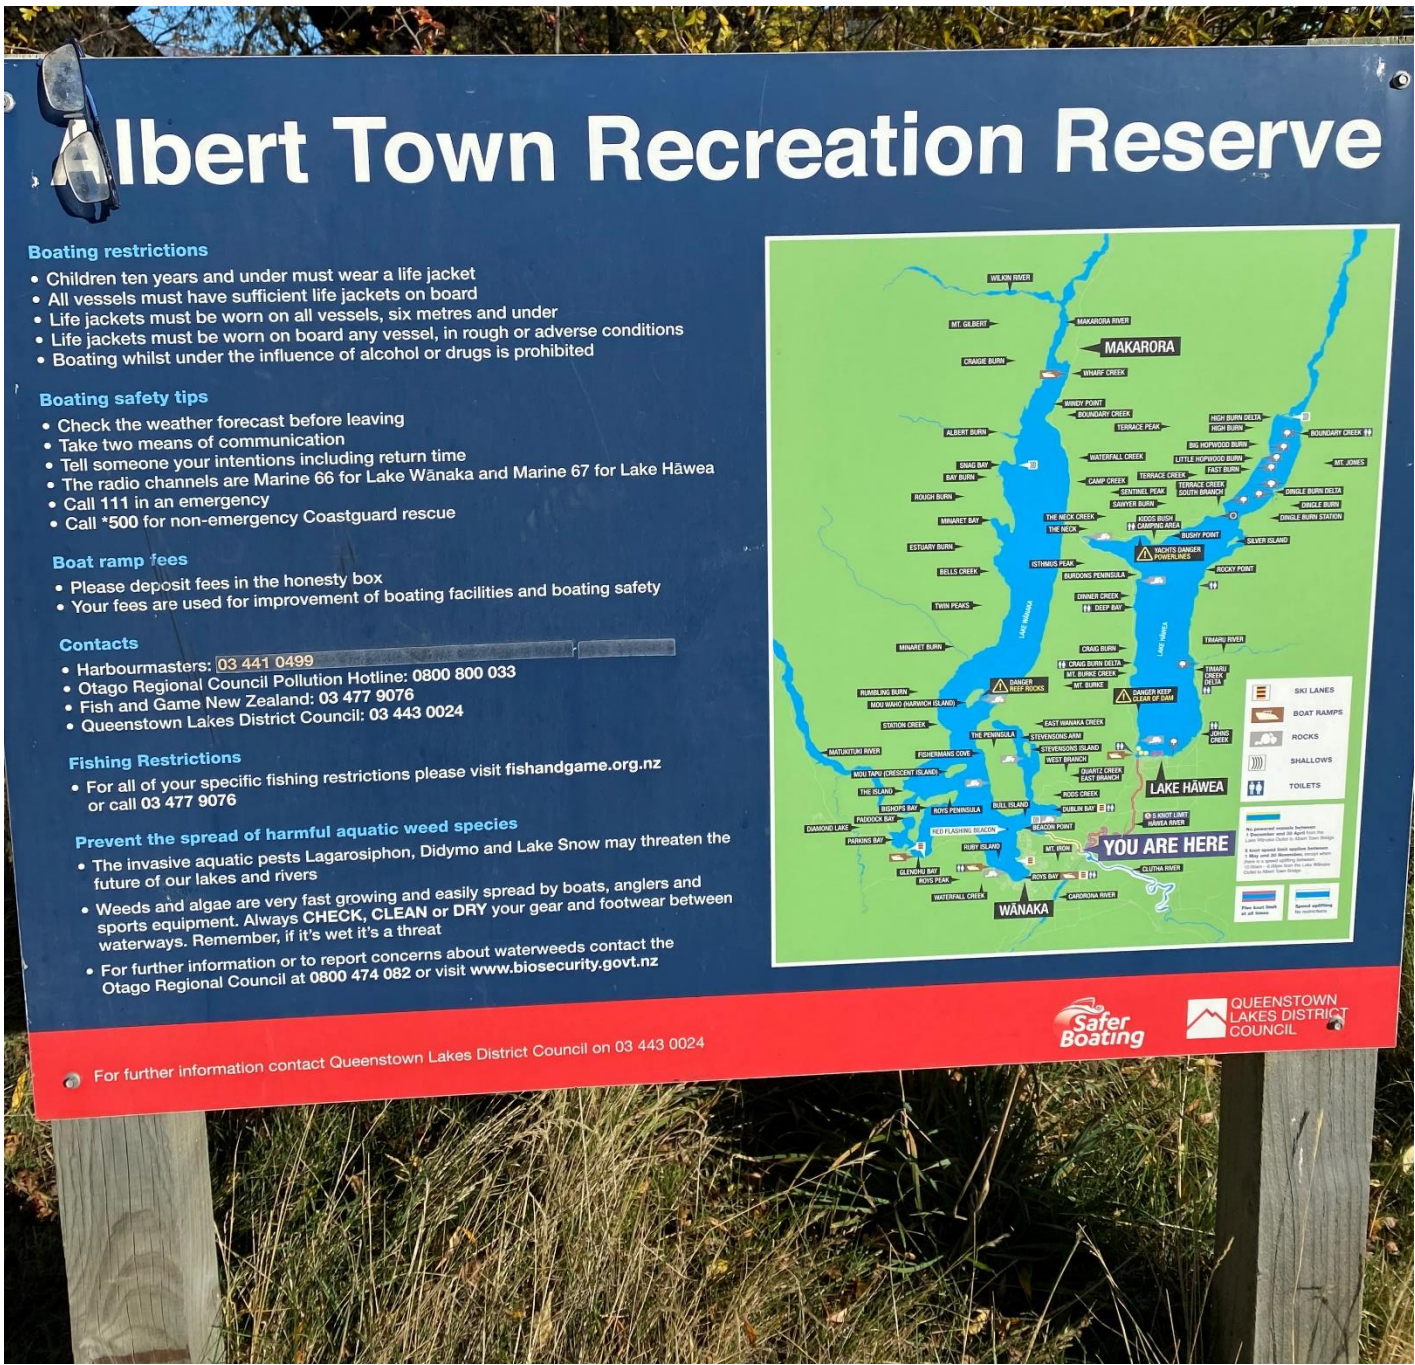
Figure 3 Albert Town Recreation Reserve Signage

# Albert Town Recreation Reserve

## Boating restrictions

- Children ten years and under must wear a life jacket
- All vessels must have sufficient life jackets on board
- Life jackets must be worn on all vessels, six metres and under
- Life jackets must be worn on board any vessel, in rough or adverse conditions
- Boating whilst under the influence of alcohol or drugs is prohibited

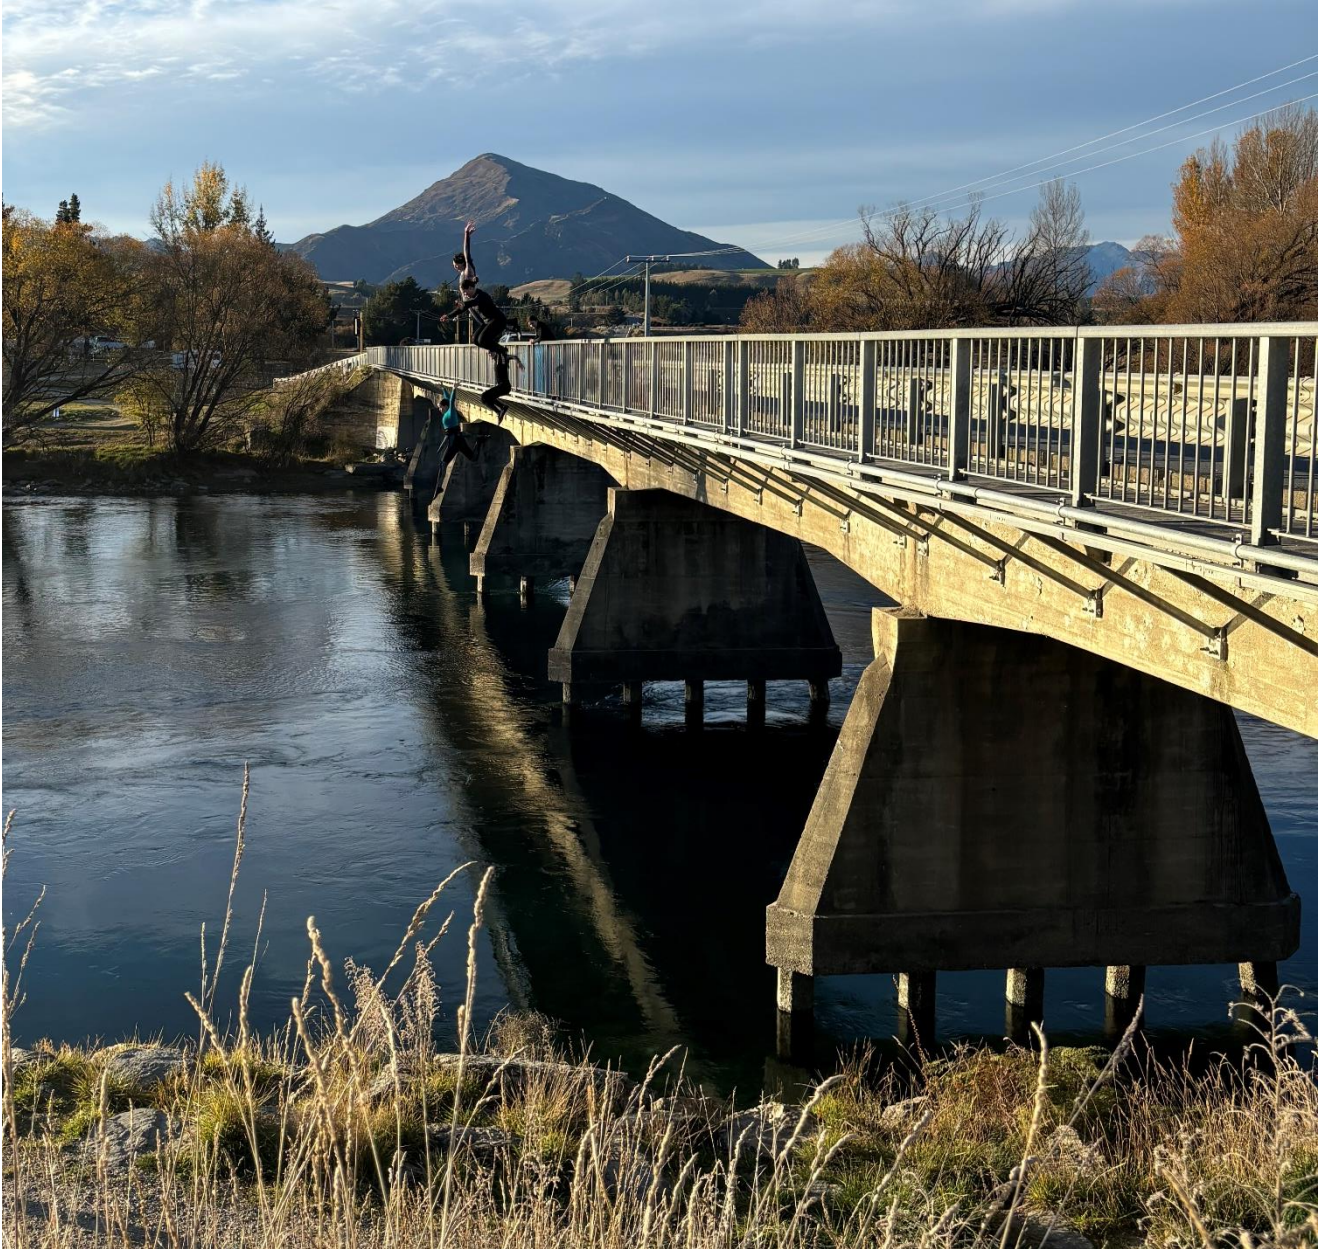
Slippery surfaces/ rocks/ shoreline are an issue at this site. Walking along the riverbank, climbing the bridge railing and climbing the jumping tree may prove hazardous due to the slippery surfaces, rocks/ shoreline and may result in abrasions, bruising and broken bones from slips, trips, and falls. It was noted that there was also a high risk of slipping and falling from the railing of the bridge into oncoming traffic at the Albert Town Bridge site.

*Figure 7 Bridge Jumpers*

- Recommendation: Consider installing a council approved permanent jumping platform to prevent the public from scaling slippery barriers and ensure safe access to the water. Coordination with the New Zealand Transport Agency, which plans to upgrade the bridge in three years, could incorporate this platform into the new design. Alternatively, a higher

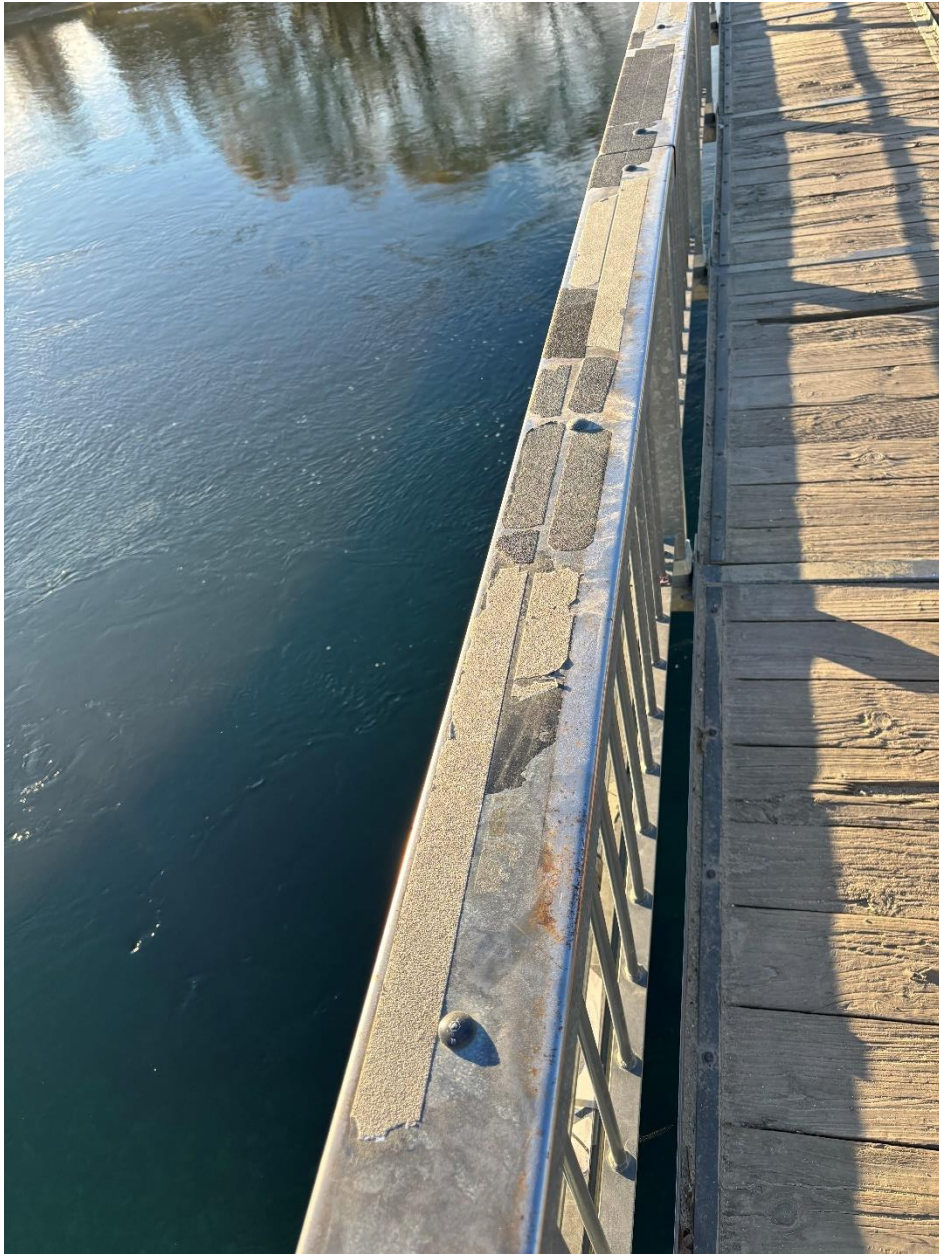
*Figure 8 Grip Tape Installed on Preferred Jumping Zone*

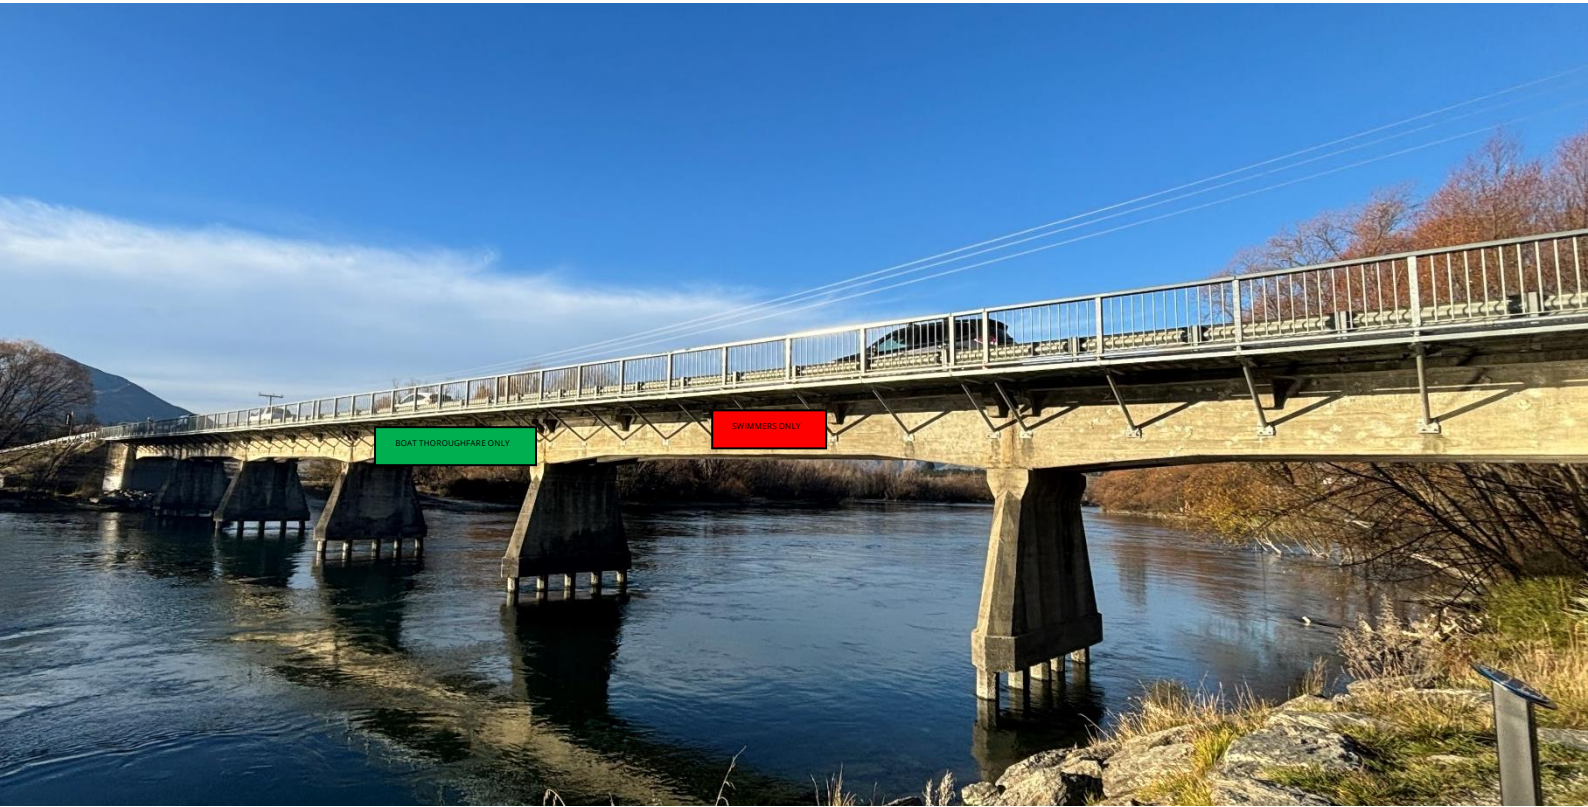
*Figure 9 Exemplary Bridge Signage Concept – Green Sign (Boat Thoroughfare Only), Red Sign (Swimmers Only)*

- Recommendation: Establish and signpost a designated boat thoroughfare lane under the bridge, separate from the jumping area, to minimize collision risks.
- Impact: Provides a clear and safe passage for powered craft, reducing the likelihood of collisions with bridge jumpers.

| Powered craft user | 6<br>High risk.<br>Further action recommended. | A boat throughfare lane should be identified underneath the bridge to provide powered craft users through a defined access point when travelling underneath Albert Town Bridge. This thoroughfare should be separate to the manu/jumping area of the bridge. The middle lane of the Albert Town Bridge should be sign posted as powered craft throughfare to reduce the likelihood of collisions with bridge jumpers. | Moderate |

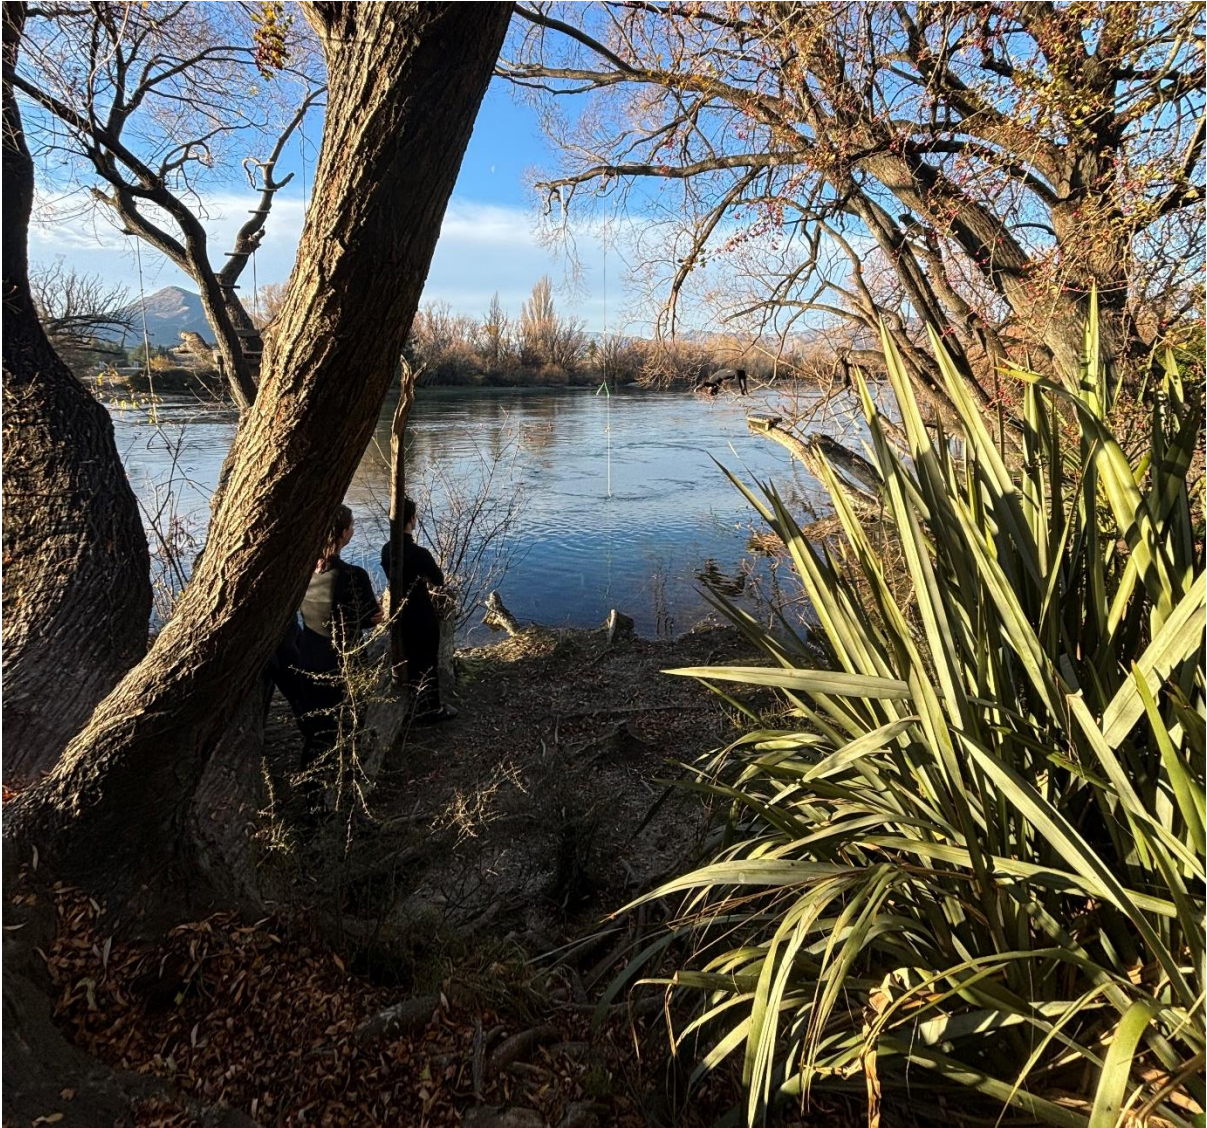
| <p><b>Brief Description:</b></p> <p>This site is situated approximately 20 metres downstream from the main jumping point on the Albert Town Bridge. There is no parking directly at this site, but users appear to walk and may park on the roadside on the south of the bridge or on the north of the bridge in either the campground or in the boat ramp park, cross the bridge and access this site.</p> <p>The jumping tree site possesses a moderate sized bank under shady trees with an apparent storm water drain running through the middle of the area with worn grass indicating a high traffic area where members of the public may choose to recreate. This area poses several access points to the riverbank that have been worn through the trees on the bank.</p> <p>There is a moderate sized tree with four observed swinging ropes from several trees as seen in Figure 10 that members of the public were witnessed to be jumping from. There are also numerous wooden steps and structures nailed into the tree to encourage access to jumping platforms that were installed at estimated heights of two and four metres above the rivers surface. The assessor noted the questionable structural integrity of the wooden structures and rope swings.</p> <p>Beneath the jumping platforms and ropes lies a shingle riverbed with a sudden drop off and partially submerged vegetation in a close proximity downstream from the entry points. Both of these hazards would likely catch members of the public unaware as they recreate at this spot. When the bank becomes wet, egress from the site may also pose a challenge to members of the public due to the steep incline of the bank and the sudden drop off.</p> <p>The main hazards present at this site are the fast flowing current, cold water, sudden drop offs, entanglement risk in vegetation, and lack of supervision which may result in harm.</p> | | |

*Figure 10 Tree Jumping Platforms and Ropes*

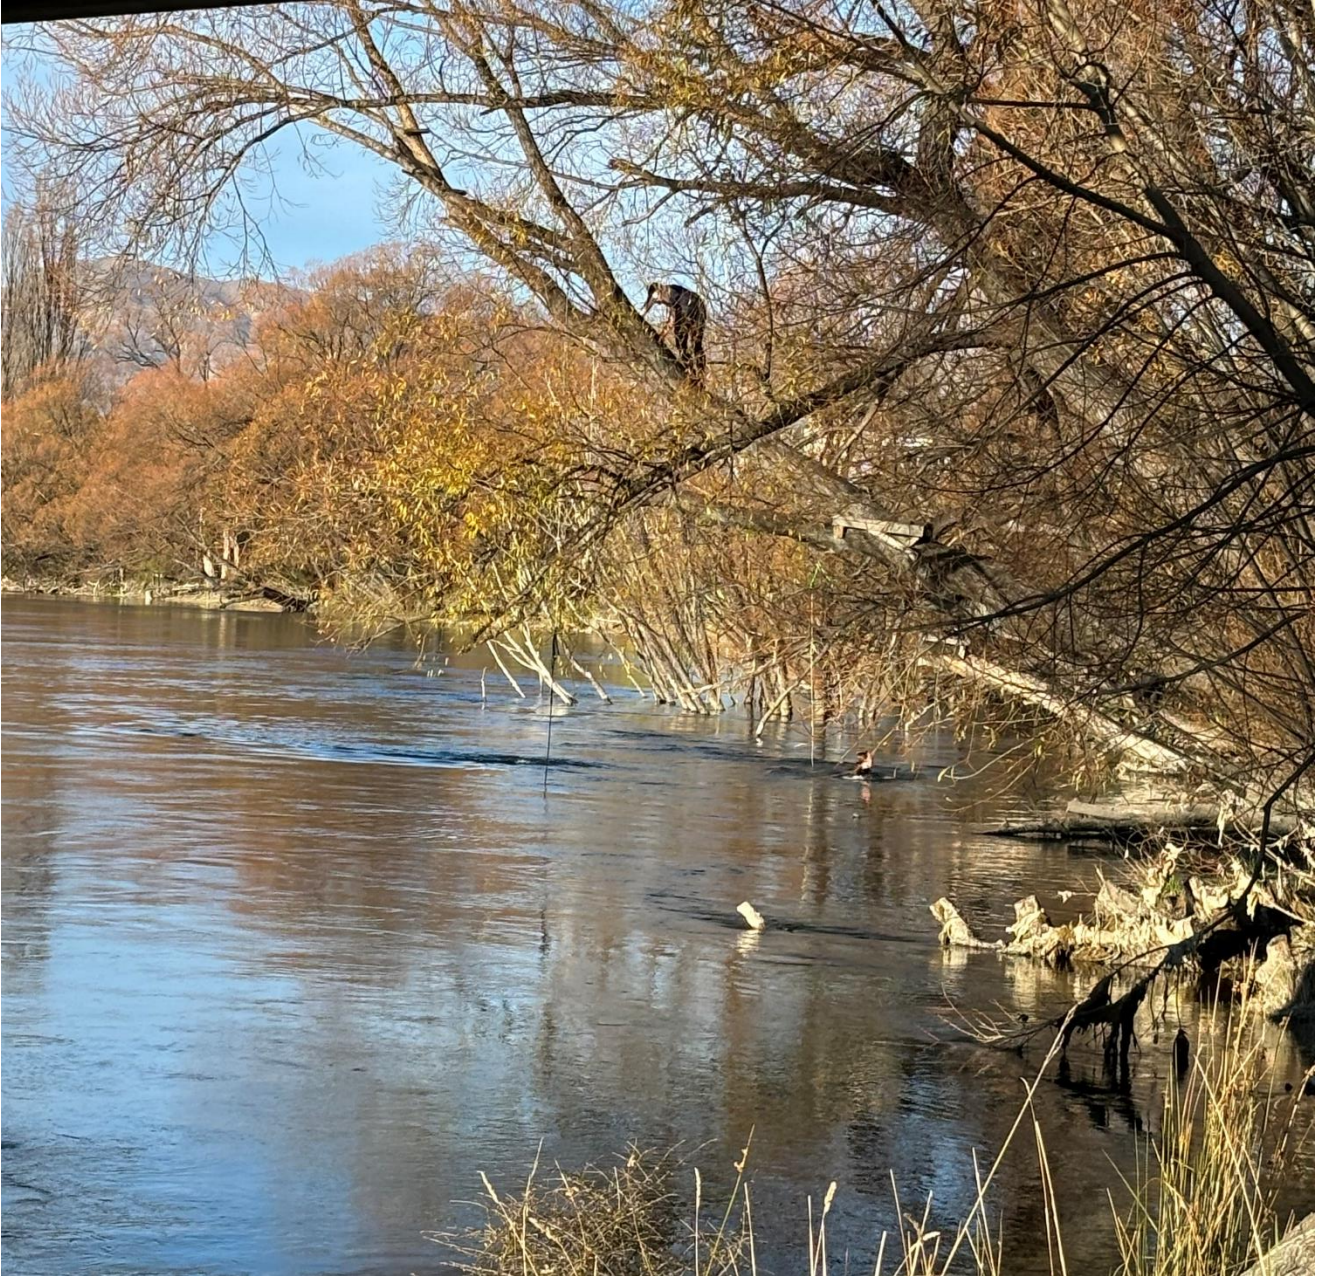
Higher levels of water or decaying trees can dislodge logs, fallen branches, rocks, and other objects creating strainers which may cause members of the public to become entangled in these hazards. Whether the person is fully or partially submerged in the water, it can be difficult to escape and may result in injury and/or drowning. It was noted that the strainers were very prominent and abundant posing a high-risk downstream area from the tree jumping site.

Tree growth in multiple locations at the tree jumping site creating overhanging sweepers. The branches/trunks of sweepers form obstructions that are hazardous for recreational users paddling craft, river drifting or boating on the river. These are particularly prominent at the tree jumping site.

*Figure 11 Downstream Vegetation*

- Recommendation: Remove downstream strainers to prevent entanglement of capsized crafts and install public rescue equipment with instructions.
- Impact: Reduces the risk of drowning and injury from entanglement, enhancing overall water safety.

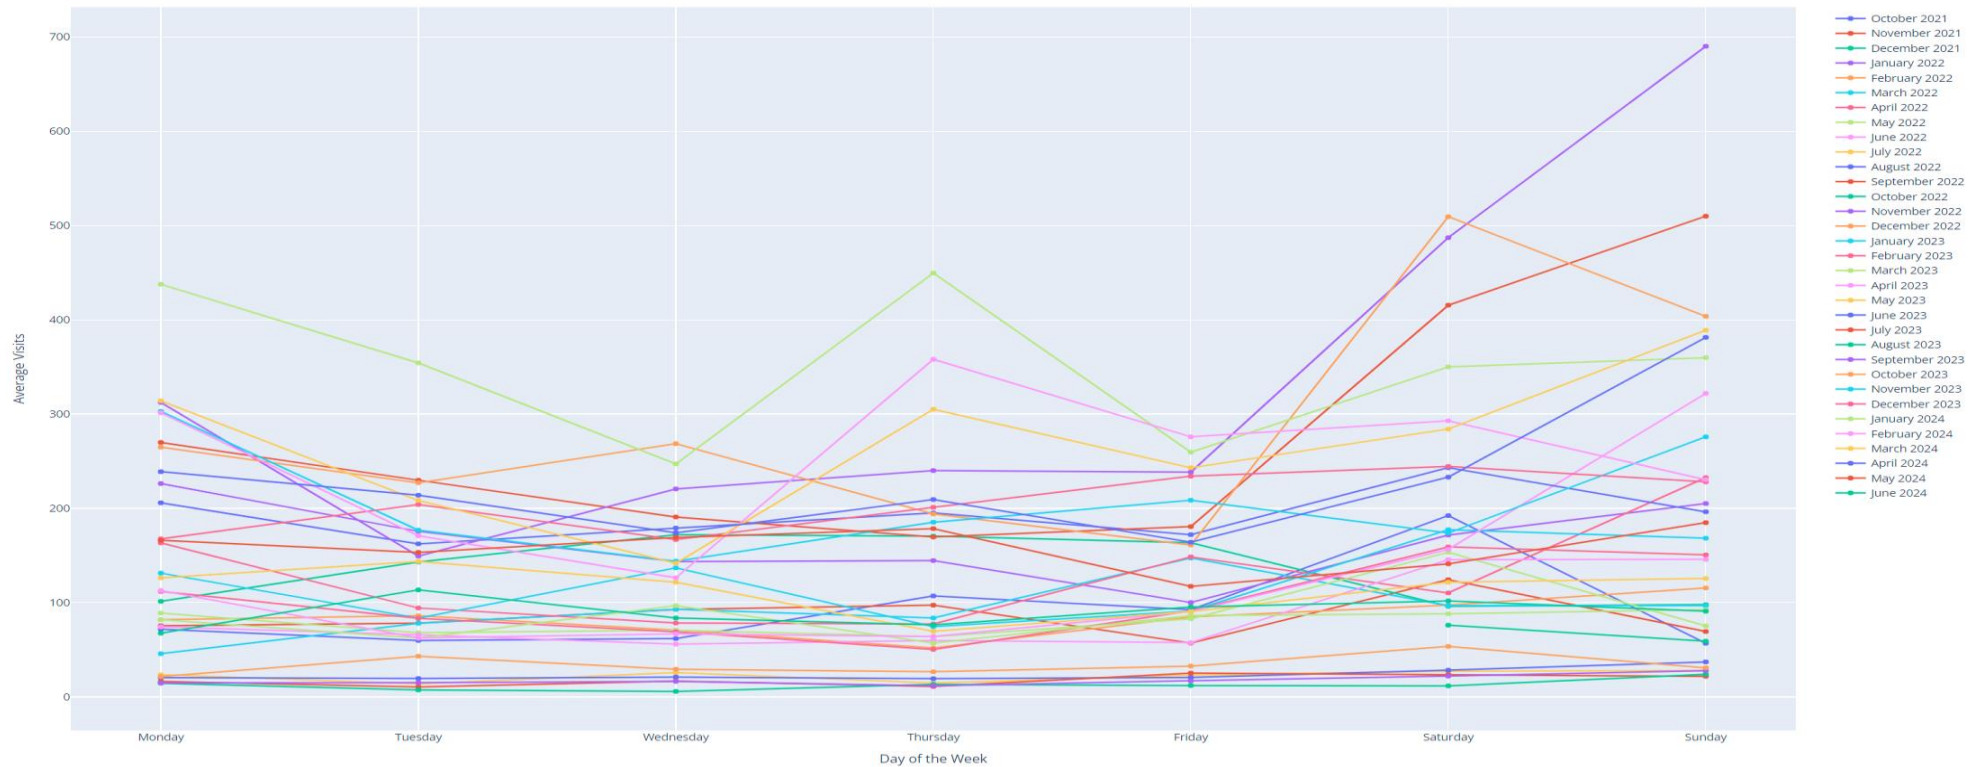
Figure 14 Albert Town Bridge Filtered User Data – Days of Week Use

Road traffic and anyone moving over five kilometres per hour (to remove cyclists) has been removed from this data to enable accurate identification of the most popular days of use at the site from October 2021 – June 2024. Data shows that Sunday is the most popular time to visit this site. This data is captured using refined and filtered ActiveXChange datasets.

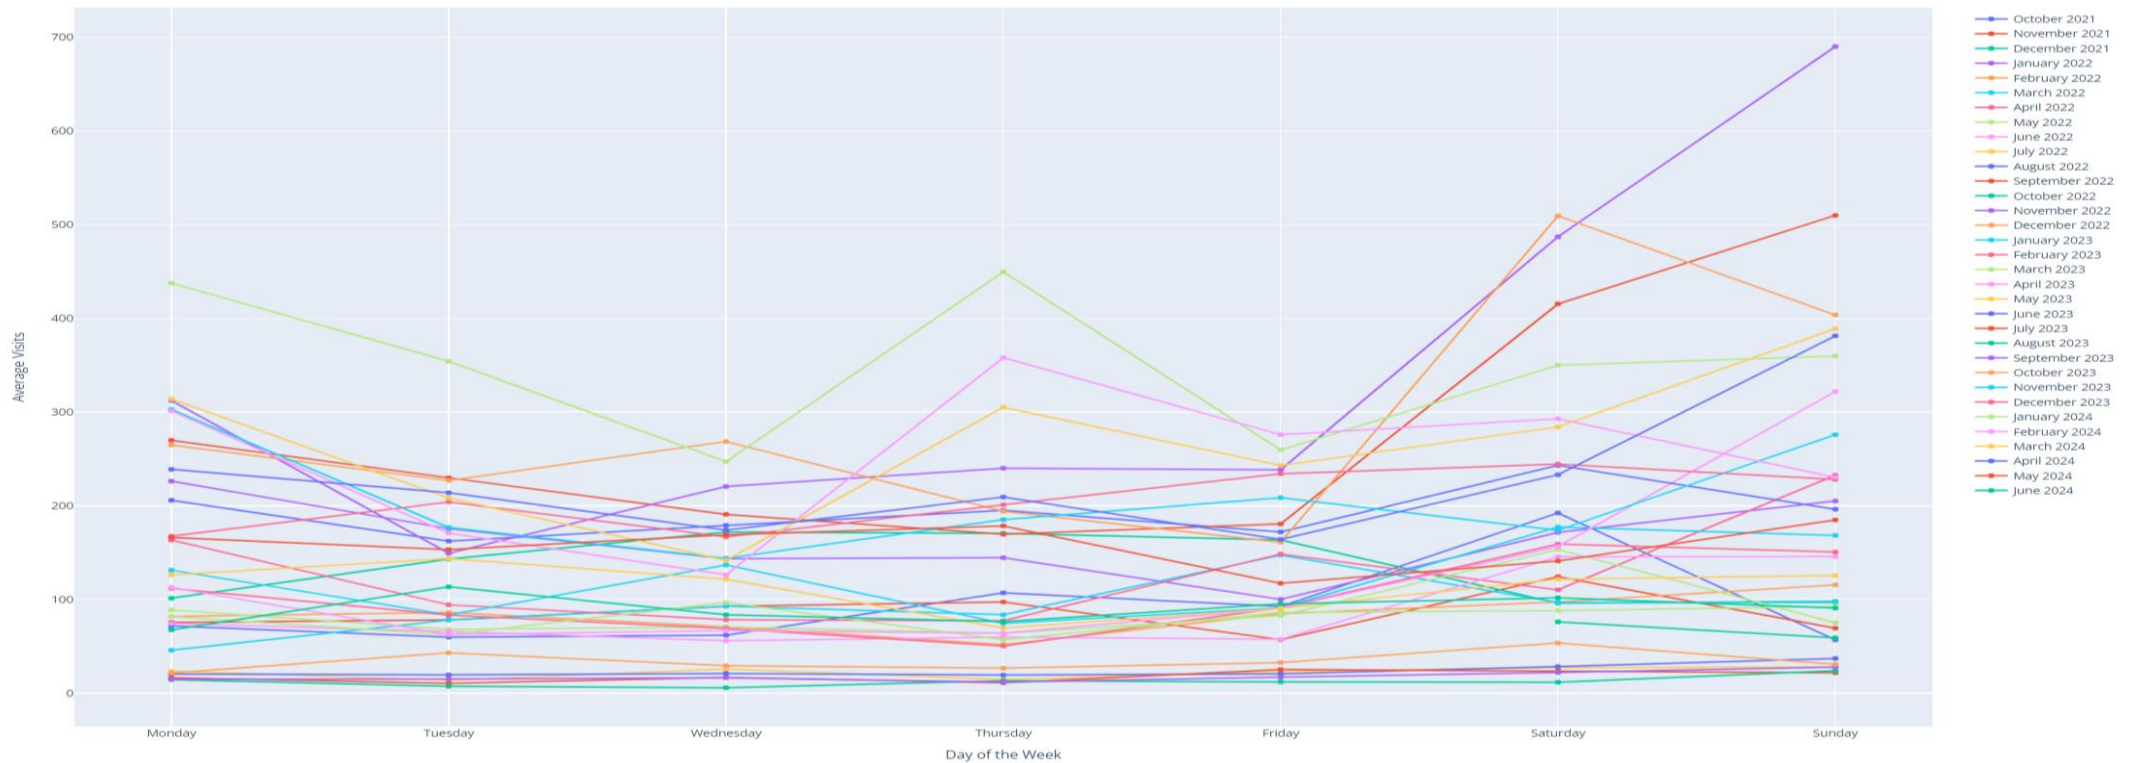
Figure 16 Jumping Tree Filtered User Data – Days of Week Use

The trail data has been removed from this dataset to enable accurate identification of the most popular day to visit this site from October 2021 – June 2024. Data shows the most popular day to visit this site is on a Sunday. This data is captured using refined and filtered ActiveXChange datasets.
